# New Hampshire Volunteer Lake Assessment Program

## 2003 Interim Report for Governors Lake Raymond

NHDES  
Water Division  
Watershed Management Bureau  
29 Hazen Drive  
Concord, NH 03301

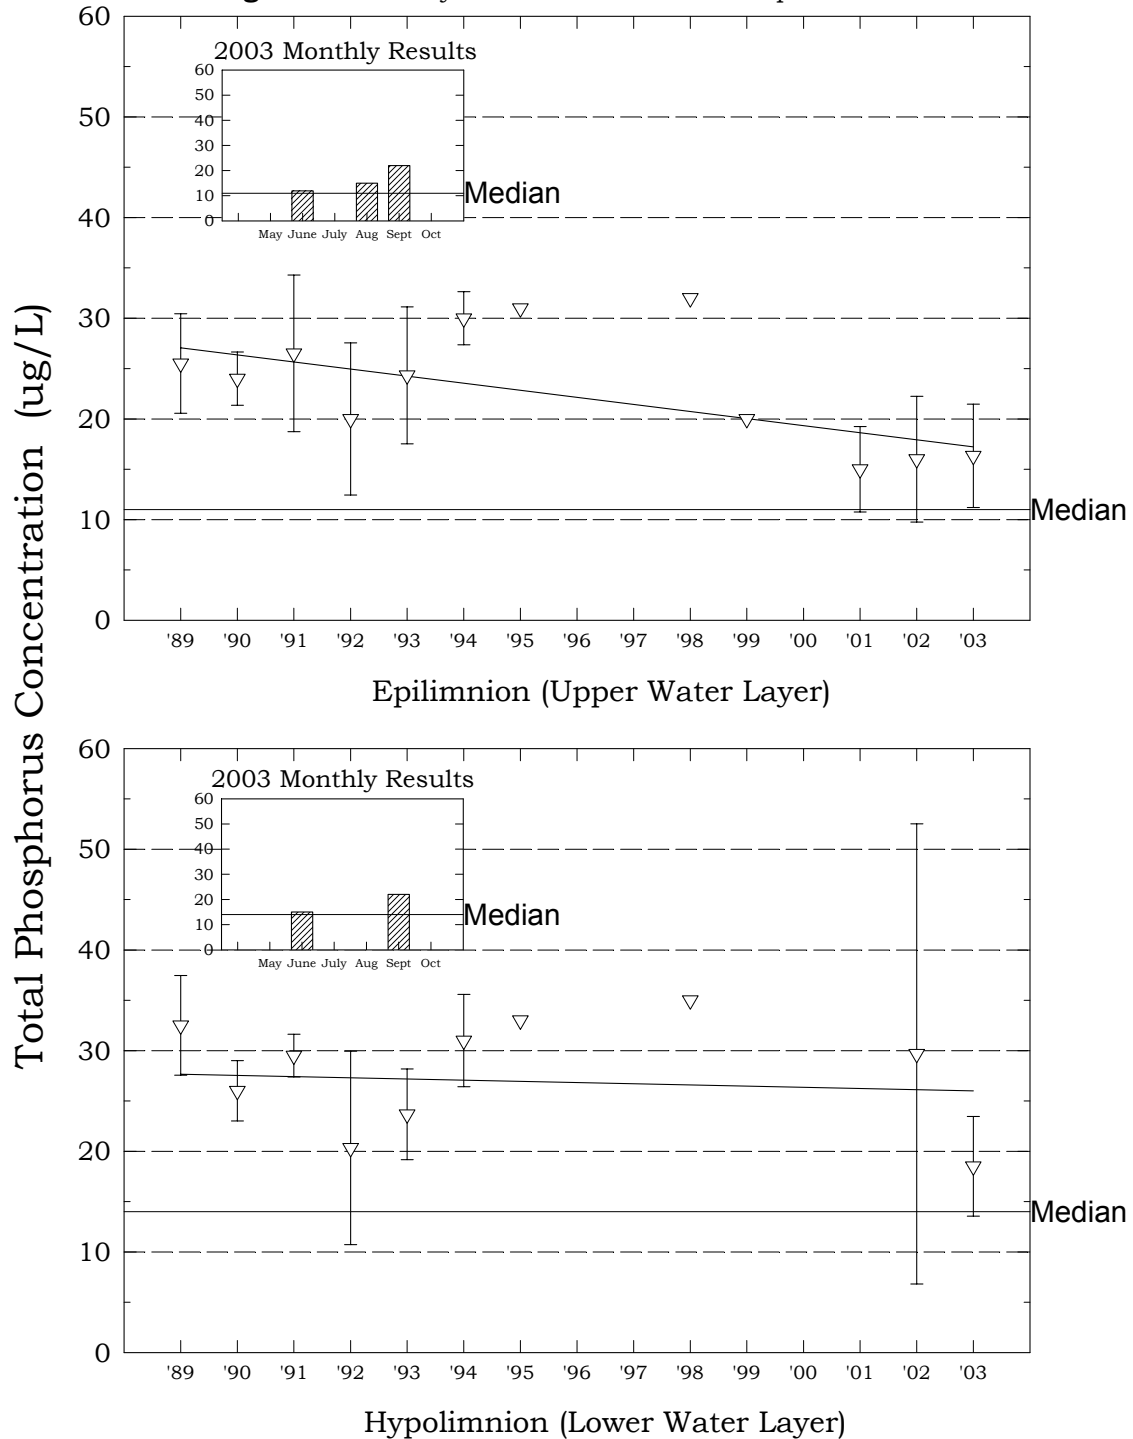
**Figure 3.** Monthly and Historical Total Phosphorus Data.

- **Figure 3 and Table 8:** The graphs in Figure 3 (Appendix A) show the amounts of phosphorus in the epilimnion (the upper layer) and the hypolimnion (the lower layer); the inset graphs show current year data. Table 8 (Appendix B) lists the annual maximum, minimum, and median concentration for each deep spot layer and each tributary since the lake has joined the program.

The current year data for the epilimnion (the top inset graph) and the hypolimnion (the bottom inset graph) show that the phosphorus concentration **increased** from June to September. The phosphorus concentration on each sampling event was **greater than** the state median. *(Please note that the epilimnion was sampled in August while the hypolimnion was not sampled.)*

The historical data show that the 2003 mean epilimnetic and hypolimnetic phosphorus concentration is **greater than** the state median.

Overall, visual inspection of the historical data trend line for the epilimnion show ***a fluctuating, but overall decreasing (meaning improving)***, phosphorus trend since monitoring began.

Overall, visual inspection of the historical data trend line for the hypolimnion shows ***a variable*** phosphorus trend, which means that the concentration has ***fluctuated*** since monitoring began.

One of the most important approaches to reducing phosphorus loading to a waterbody is to continually educate watershed residents about its sources and how excessive amounts can adversely impact the ecology and value of lakes and ponds. Phosphorus sources within a lake or pond's watershed typically include septic systems, animal waste, lawn fertilizer, road and construction erosion, and natural wetlands.
